DEPARTMENT OF ENVIRONMENT AND CONSERVATION
Division of Water Pollution Control
Surface Mining Inspection Report

RE: Results of Site Inspection
American Sand Company, LLC
Quarry 2, NPDES Permit #TN0069302
Putnam County

American Sand Co., LLC, Quarry 2
October 22, 2013

TDEC Water Resources Photo Log
By Sharon Kington ES3
Cookeville EFO

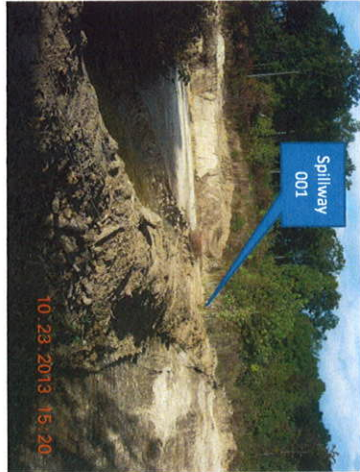
- Improper Operation and Maintenance/Inadequate Best Management Practices (BMPs): Basin 001 was overfull of sand, with sand overtopping the spillway. (See photo log enclosed).
- Discharge Monitoring Reports (DMRs): All DMRs since permit issuance have reported flow of 0.0 gallons per minute, despite sand deposits down the spillway and past the permit boundary.

1. Basin cleanout begun in overtopped
basin

Please submit a written response, including photographs, to this office by December 16, 2013, to document restoration of adequate basin capacity at Quarry 2. Please include a description of measures underway to ensure adequate monitoring. If there are questions, please contact Ms. Sharon Kington at (931)432-7633. Your cooperation in this matter is greatly appreciated. Thank you again for your promptness with regard to the renewal application.

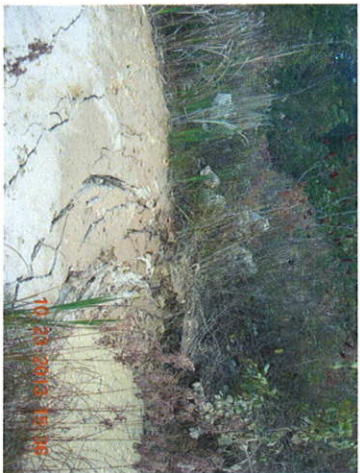
MAINT. ISSUE: POND WAS OVERFILLED (TO TOP OF SPILLWAY AND SAND FLOW TRAIL WAS DOCUMENTED ON BOTH EDGES OF SPILLWAY. FAILURE TO MAINTAIN IS PERMIT VIOLATION

2. Sediment loss through DMP 001
spillway.

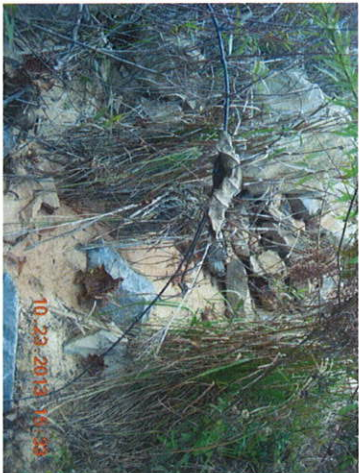
3. Sediment in spillway below
DMP 001.

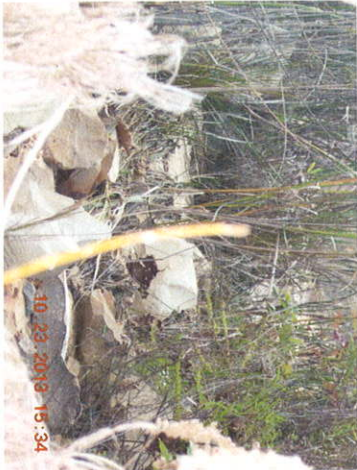
4. View of sediment trail extending past spillway and past permit boundary.

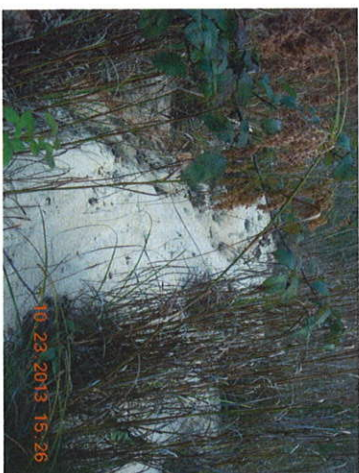
5. Sediment deposit past permit boundary among wetland vegetation.
